Monitoring and Analysis of Frozen Debris Lobes, Phase IB

September 2015

INE/AUTC 15.09

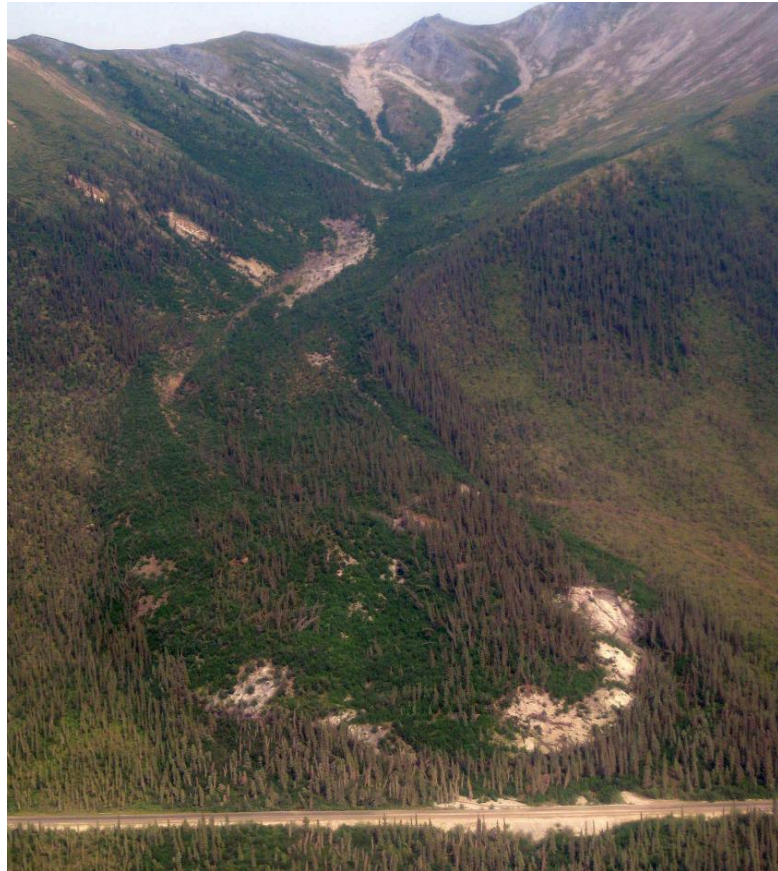
FDL-A at MP219 along the Dalton Highway in June 2013.

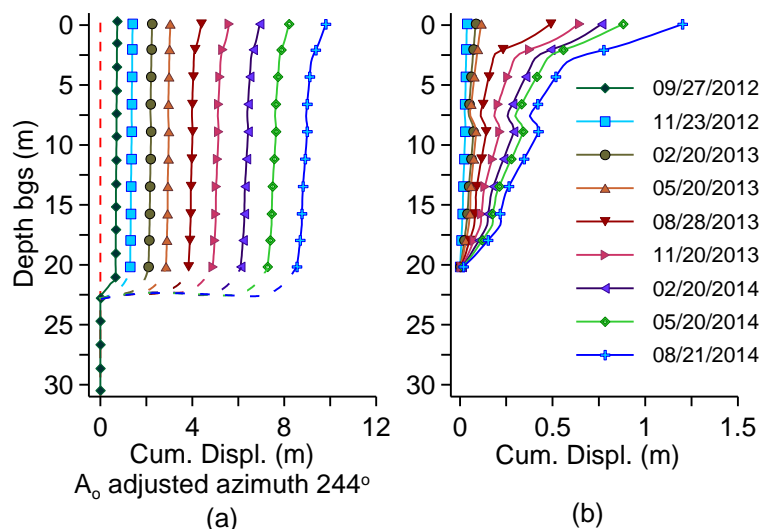
Figure 2. Cumulative displacement measurements reported by the M-IPI device installed within FDL-A. Shear zone is approximated with dashed lines (a). The data in (b) show only movement from above the shear zone at 20.1 m below the ground surface (bgs).

Movement of FDL-A occurs mainly as shear within a zone near the bottom of the lobe (see Figure 2). The M-IPI data reveal that movement also occurs as internal flow, which is temperature-dependent (see Figure 3). Combining these two modes of movement, FDL-A currently moves about 7 m per year in its upper reaches, and about 4 to 5 m per year near the toe (see Figure 4). Over the 2013-2014 measurement year, it moved at an average rate of 1.3 cm per day. Data for the 2014-2015 measurement year are currently being analyzed to determine movement rates.

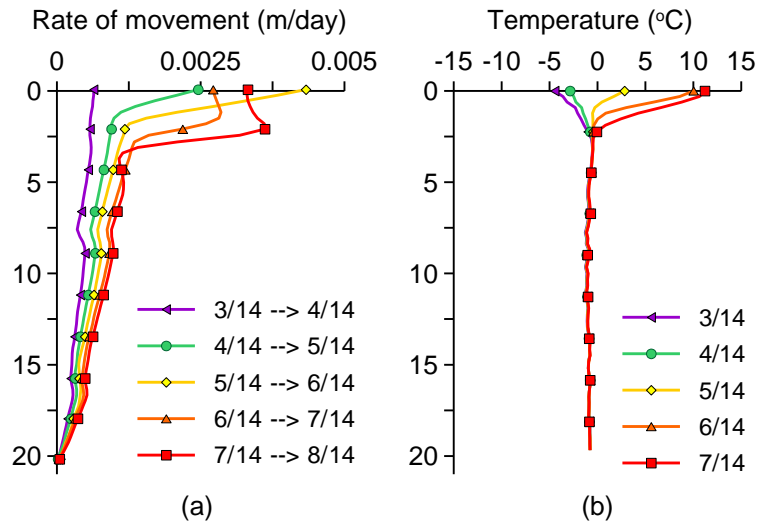
Figure 3. Monthly rate of movement (a) and subsurface temperatures (b) of FDL-A, for part of 2014.

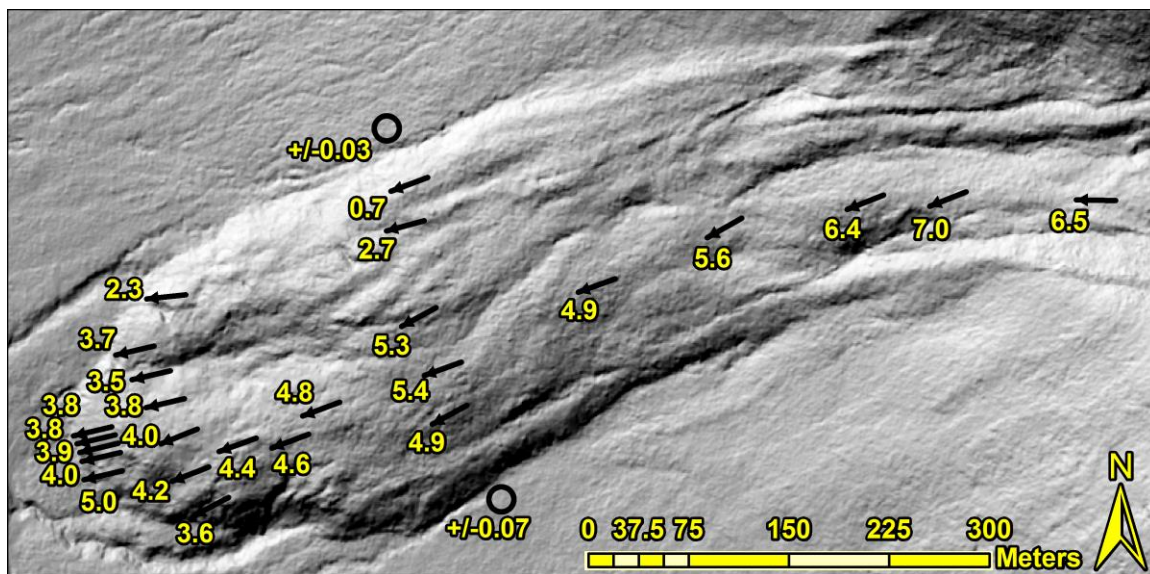
Figure 4. Summary of movement of FDL-A from August 28, 2013 to August 21, 2014. Arrows indicate direction of movement, and numbers are amount of movement in meters. (Base map data from Hubbard et al. 2011.)

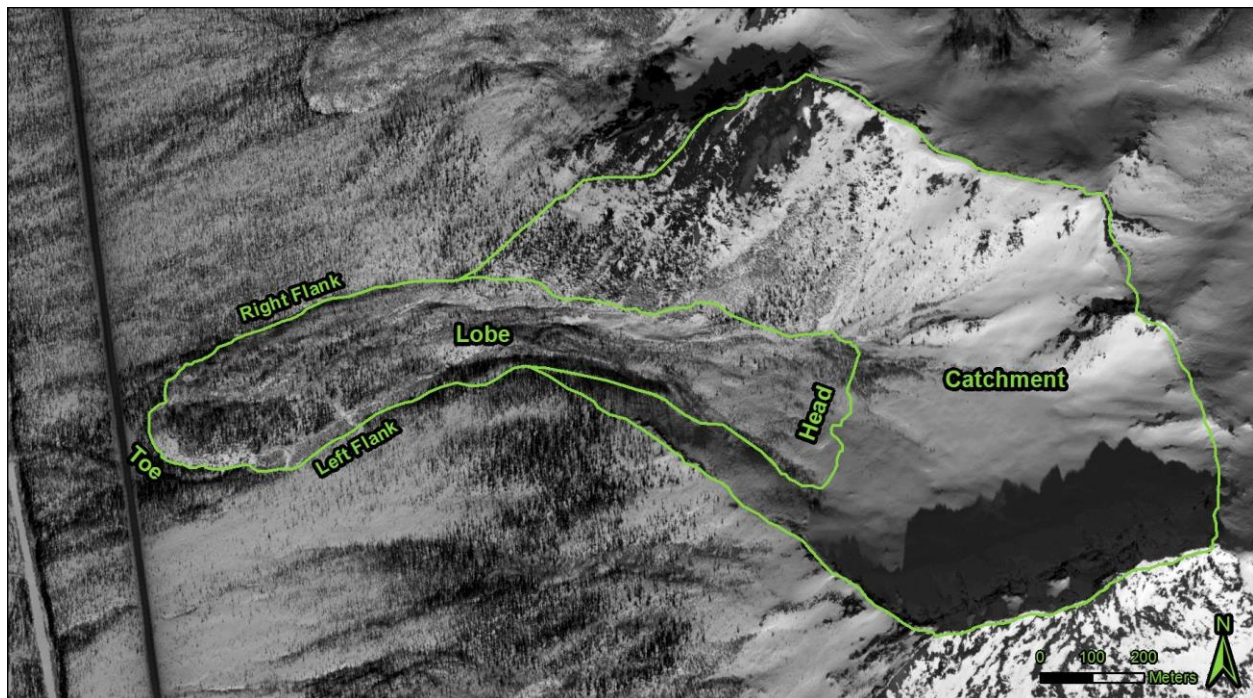
Figure 5. Delineation of FDL-A lobe and catchment extents. (Base map data Copyright 2014 DigitalGlobe, Inc.)

In addition to summarizing the fieldwork conducted on FDL-A since 2012, this paper presents the GIS analysis of FDL-A and its catchment, investigating characteristics such as catchment and lobe area, slope angle, slope aspect, geology, and vegetation height and coverage. The GIS analysis was conducted as a pilot study to guide future GIS work when high-resolution
